# ENGINEERING SUPPORT PROGRAM

EVALUATION OF PUL-E-KHUMRI I & PUL-E-KHUMRI II  
MINI-HYDROELECTRIC POWER PLANTS  
CITY OF PUL-E-KHUMRI,  
NORTHERN AFGHANISTAN

MAY 2, 2010

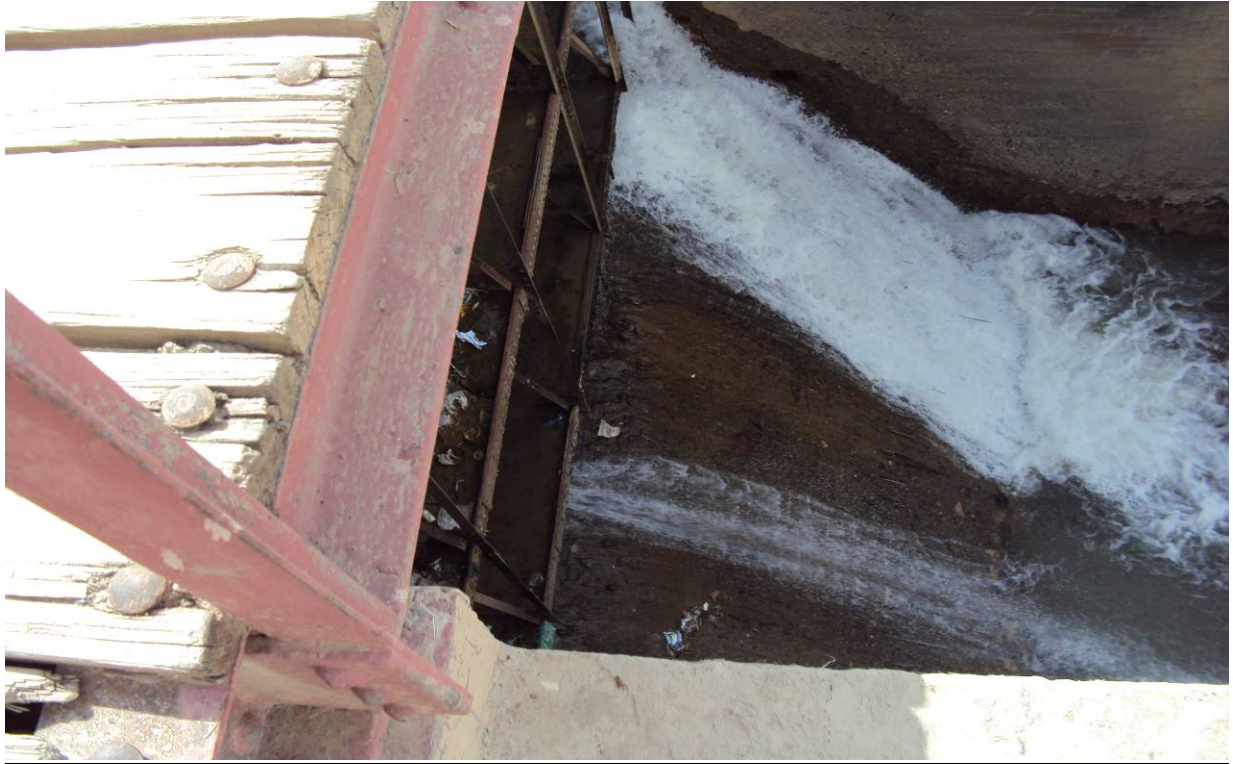
The severe erosion of the ogee spillway crest, chute and apron was also observed during the Tetra Tech site visit. However, this erosion could only be observed from a distance so its full extent is unknown, but it appears severe. The USACE previously reported that the damage was such that it threatens to undermine the spillway structure itself causing catastrophic collapse. A structural evaluation needs to be performed for the ogee spillway, chute and apron structures in each bay and remediation repairs performed as soon as possible. The structural evaluations need to include the spillway wall sections below the ogee crests. The lower sections of these walls should also be filled/fixed with concrete as well as with additional steel plate sheeting anchor-bolted to the walls to provide future protection against the adverse erosive effects of hydraulic jump conditions against the concrete, in addition to, the negative effects of freeze and thaw icing conditions during the winter period. (The negative pressure distributions that can occur within a given hydraulic jump situation have significant erosive potential against concrete.)

**Note Heavily-eroded Concrete at Ogee Crest and Along Bottom of Sidewall, Non-uniform and Uneven Spillway Flow Releases, No Safety Hand Railing at Top of Concrete Wall (no safety hand railing at either spillway sidewall), and Deteriorated Wood Planking on Walkway at Pul-e-Khumri I Hydroelectric Dam.**

**1) Spillway Ogee and Apron. Conduct a complete survey of the spillway ogee and run out (mandatory). Repair the damaged areas (optional, based on severity and cost estimate).**

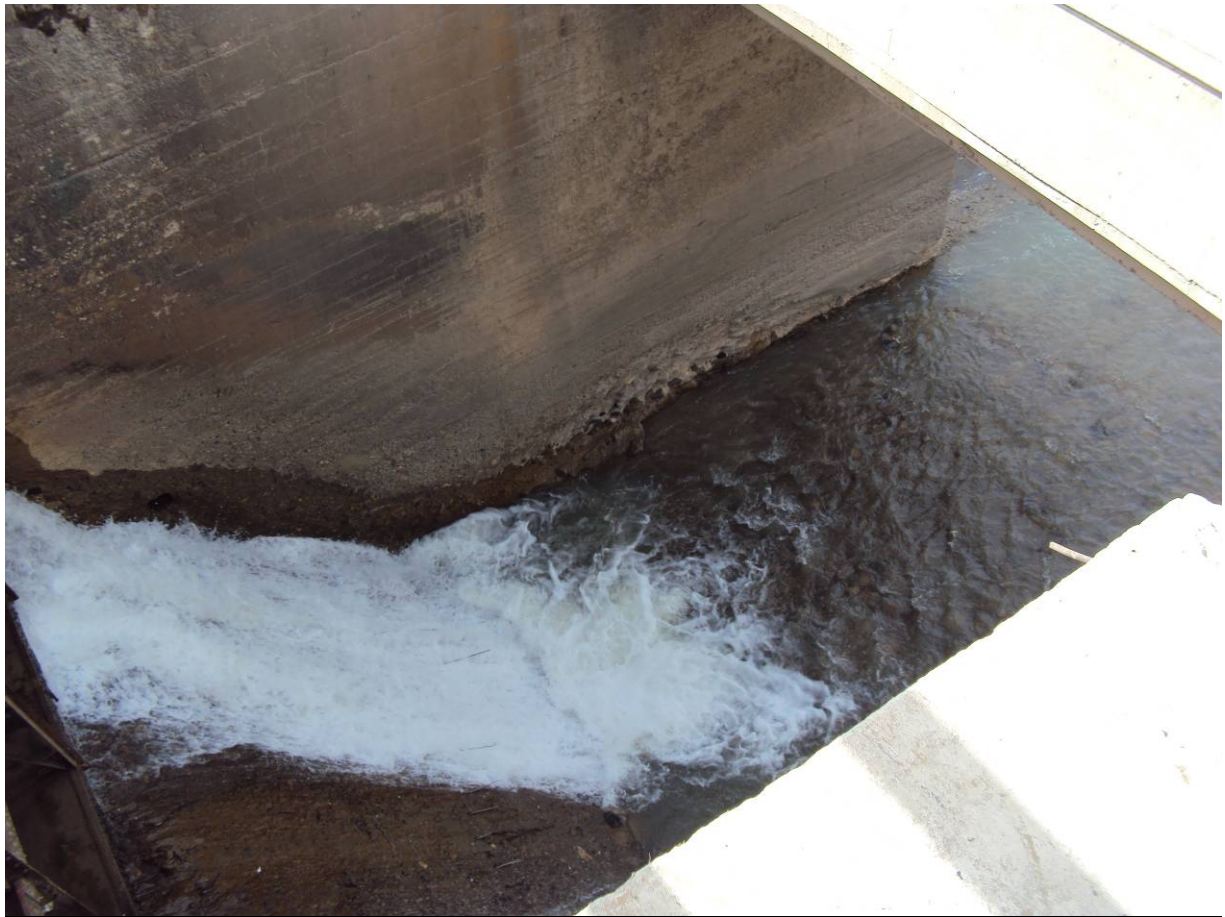
**Another View of Heavily-eroded Concrete Along Bottom of Sidewall at Pul-e-Khumri I Hydroelectric Dam. Take Note of Hydraulic Jump Flow Pattern on Sidewall.**

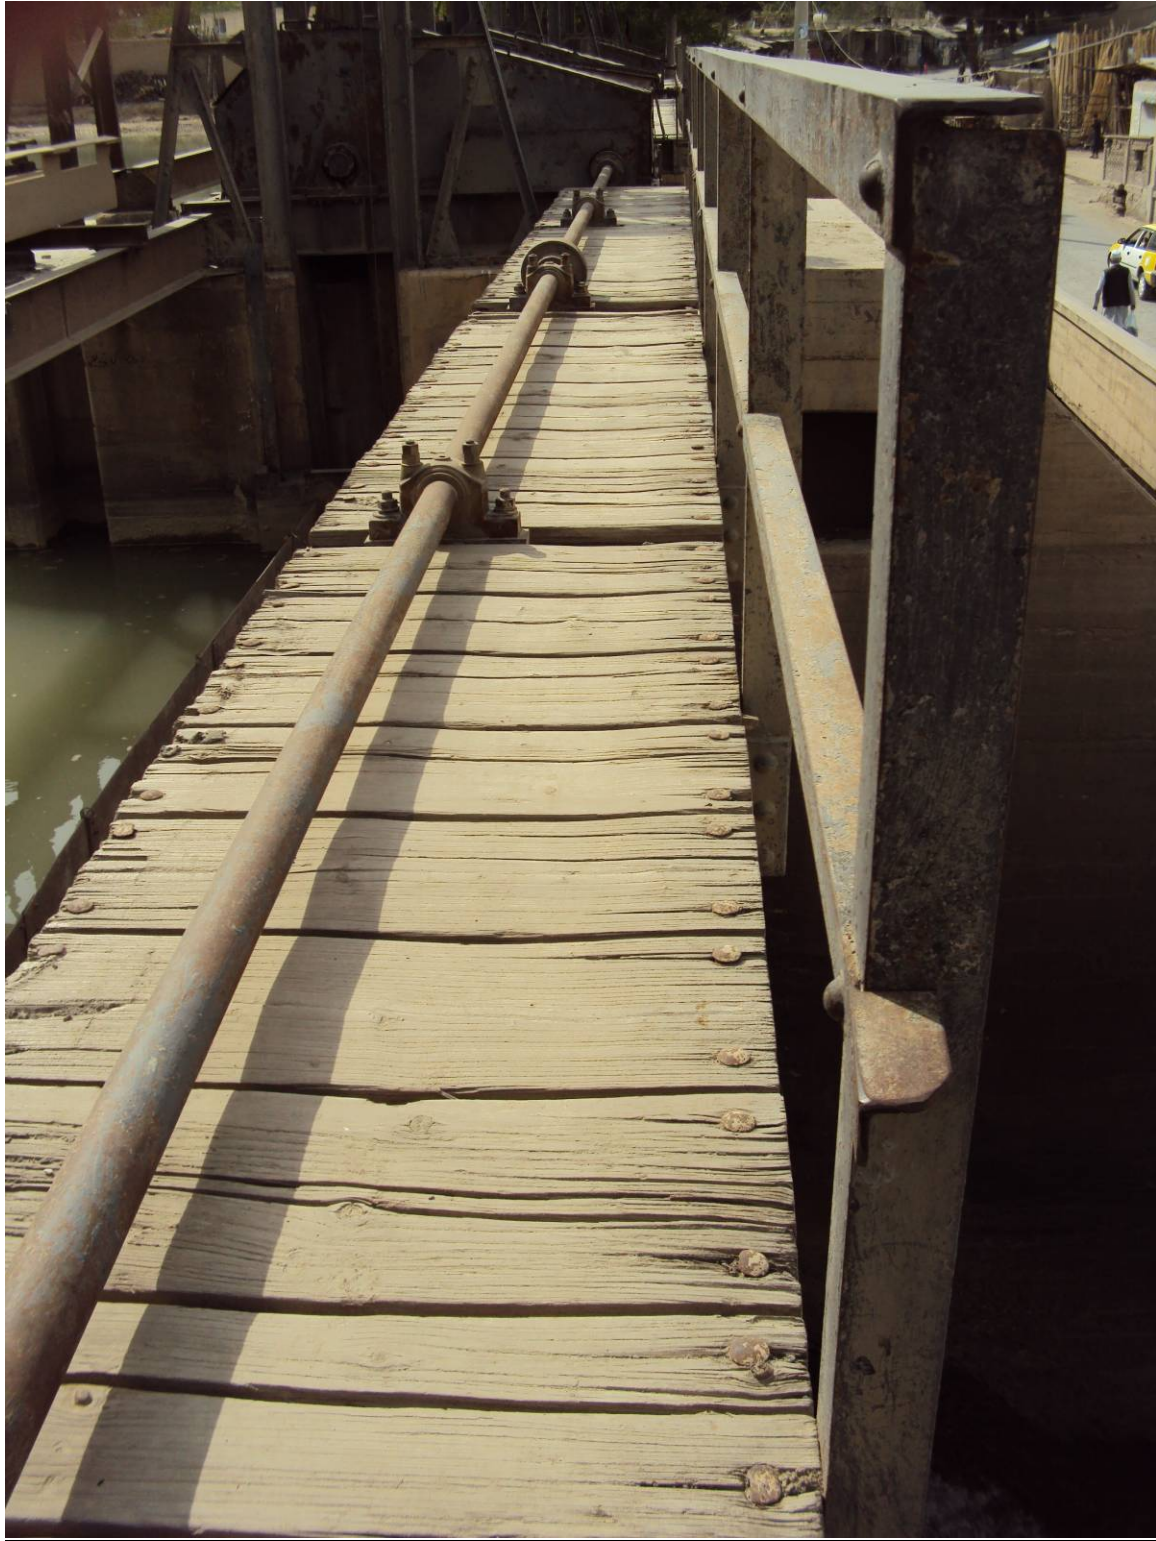
**View Indicates Deteriorated Wood Planking on Walkway and No Safety Handrail at Left Side of Walkway at Pul-e-Khumri I Hydroelectric Dam (top of ogee spillway is below walkway and is hidden from view).**

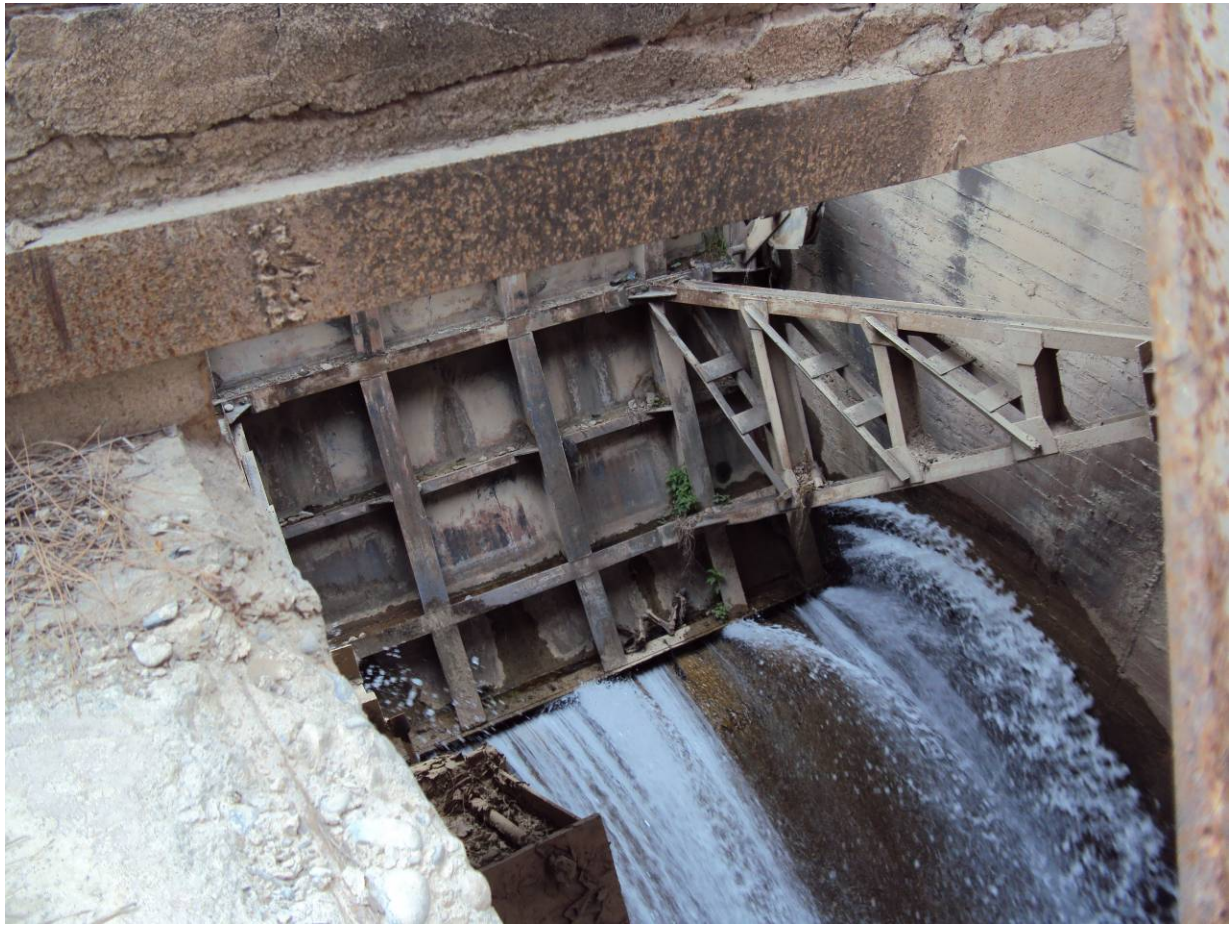
To Tetra Tech, the spillway gates and seals appeared to be in the same condition as observed during the previous USACE inspection. Again, an examination of gate opening procedures was not conducted due to time constraints and present plant operations.

**An Example of a Leaky Gate on Ogee Crest of Spillway at Pul-e-Khumri I Hydroelectric Dam. Also Note Horizontal Crack in Top Concrete Section.**

**b. Spillway gate operability and seals. Inspect the gate operability and seals (mandatory) and repair or replace any gate wheels and gate seals (with PVC seals if appropriate).**

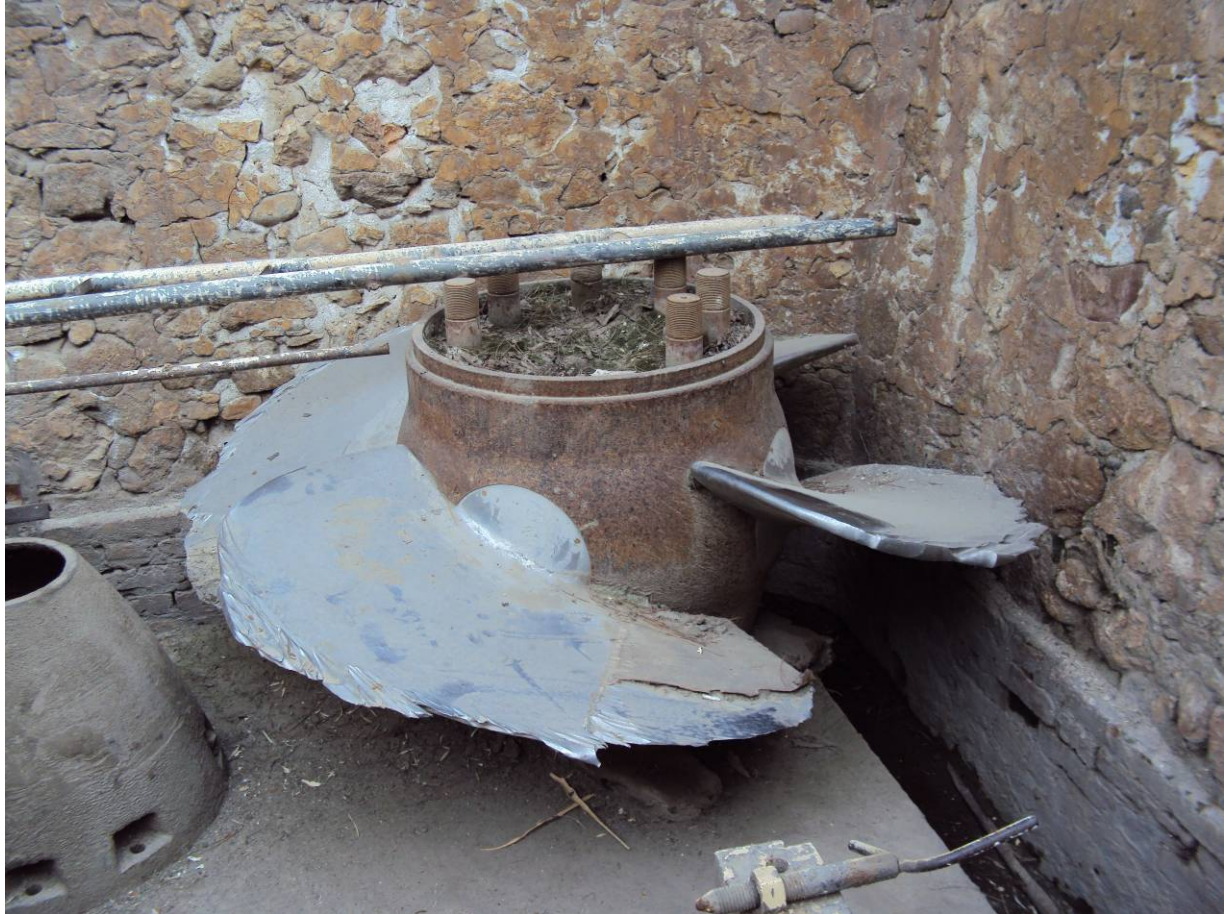
Most of the mechanical equipment at the existing Pul-e-Khumri I mini-hydroelectric power plant facility reportedly is original, except for the turbines which were replaced (circa 1970) because of extensive erosion and cavitation damage to the turbine runner blades. However, the existing turbines previously installed reportedly had been “used” equipment from another plant and were not specifically designed for this plant facility. The runner blades of the existing turbines also have undergone considerable erosion and cavitation damage.

**Severely-eroded Turbine Runner Blades from Effects of Cavitation at Pul-e-Khumri I Hydroelectric Power Plant Facility (note evidence of welded steel plate repair work).**

In the USACE April 2008 report, short-term recommendations were made relative to the mechanical components of the Pul-e-Khumri I facility that included the replacement and/or rebuilding of the governors and the installation of new turbine runners, couplings and guide bearings. The USACE short-term electrical recommendations were made to repair the governor system and voltage regulators, repair the main unit breakers, feeders, disconnects and miscellaneous electrical equipment, and perform miscellaneous diagnostic testing of the generators and transformers. Other short-term recommendations included ordering/procuring spare parts, dredging the existing power channel, and replacing a leaking roof to the existing power house. The USACE further recommended that the repair and replacement work be contracted separately, however, that plant staff could be used for the labor forces.

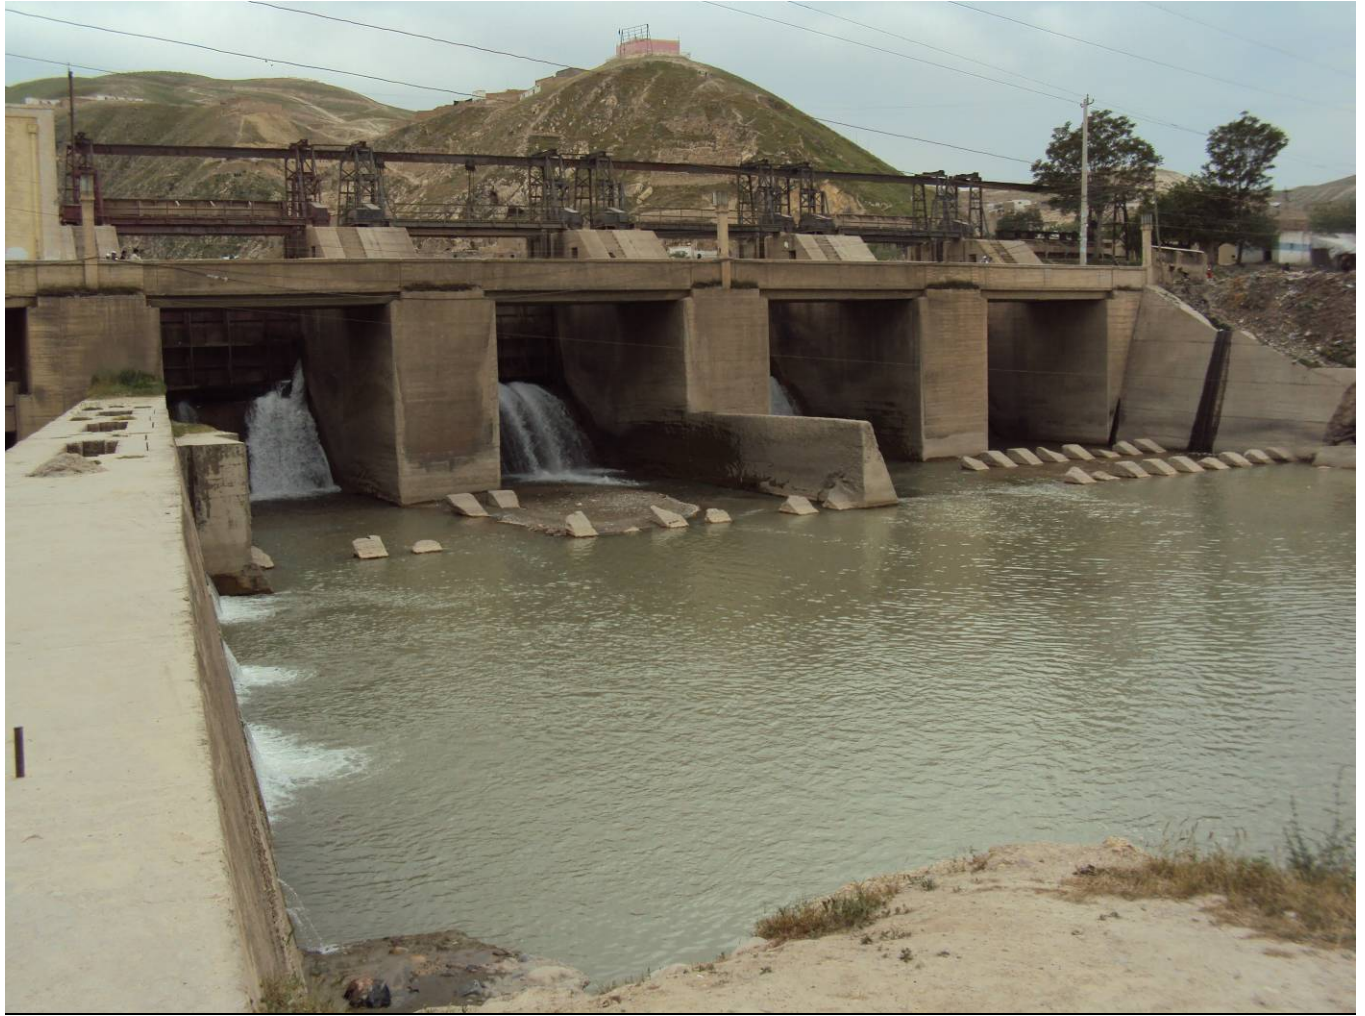
Also, it appears that at one time several concrete stilling basin blocks that had previously been located (situated) immediately downstream of the spill gates and stilling basin apron areas had been completely or partially destroyed and the concrete segments removed downstream, probably during a major flooding event(s) on the Baghlan River. (No stilling basin blocks, however, were observed as existing below Spill Gate 3. Reconstructing and/or rebuilding the stilling basin blocks in their former locations, particularly at the Spill Gate 4 location, would serve to dissipate the energy from the gate flows, and in particular, reduce the

potential of erodible flood-prone river flows, including eddy currents, at the left-bank side of the river thus reducing the chances for further damage to the left bank-side training walls and supporting foundations.

**View Shows Existing Damaged Stilling Basin Blocks at End of Stilling Basins Below Each Ogee Spillway, Except for Spill Gate 3. Several Stilling Basin Blocks and Sections Presumed as Damaged, Removed and Carried Downstream During High Flood Runoff Events on Baghlan River. Also Take Note of Wide Separation Distance of Concrete Wingwall Sections at Left-bank side of River Channel at Immediate Downstream Side of Bridge Adjacent to Pul-e-Khumri I Hydroelectric Power Plant Facility.**

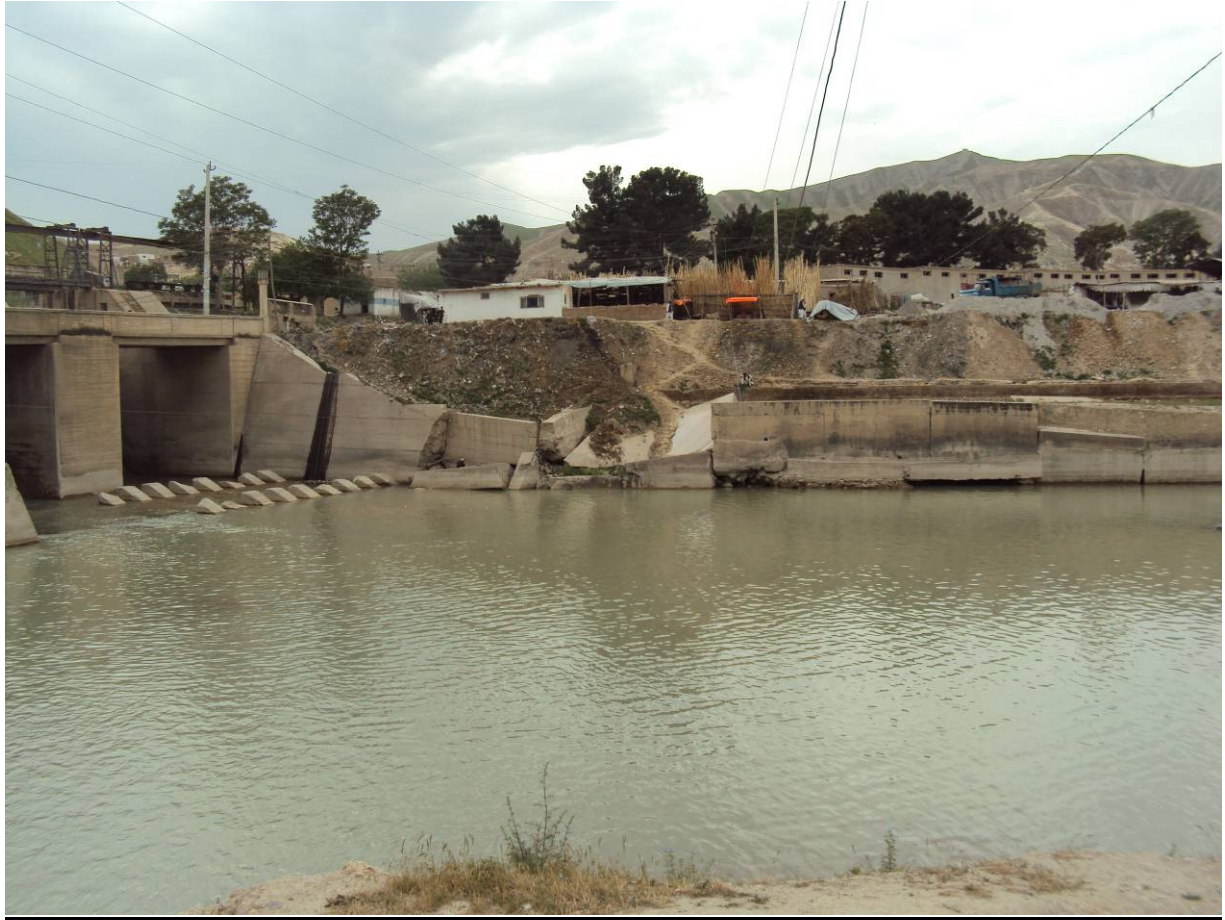
As indicated in the USACE April 2008 report, the left-bank downstream training wall is in a state of disrepair and collapse. The plant staff indicated that they no longer use Spill Gate 4 and this action subsequently reduces the potential for river flows to continue eroding the bank side. It appeared as if the spill gate had not been used for some time as there was significantly less wear here than at the other three spill gates. The plant staff also indicated that flow was typically not enough to justify all four spill gates being used. Assessing the full extent of needed repairs will require additional site-specific analysis including surveying, a local geotechnical investigation, and structural engineering designs for constructing river bank protection improvements.

**View Indicates the Existing Damage to Concrete Wall Sections Along Left-bank Side of Baghlan River Immediately Downstream of Bridge Adjacent to Pul-e-Khumri I Hydroelectric Power Plant Facility.**

**3) Left downstream training wall. The repair of this wall is not essential to power production. Complete a full survey of the damaged area, including foundation characterization (mandatory). Design and construct a repair (mandatory).**

Tetra Tech personnel were not allowed to get close to the wall section described above because of security reasons. At a minimum, a limited geotechnical investigation and ground survey would be required to prepare a remediation design for stabilizing the existing foundation condition and preparing a suitable subgrade foundation for a new reinforced concrete continuous floodwall structure to replace the damaged wall sections. Along the right-bank side too, and in like fashion, new reinforced concrete wall sections are recommended to be designed and constructed for effectively channeling river flows at this side of the river to protect against future erosion as well.

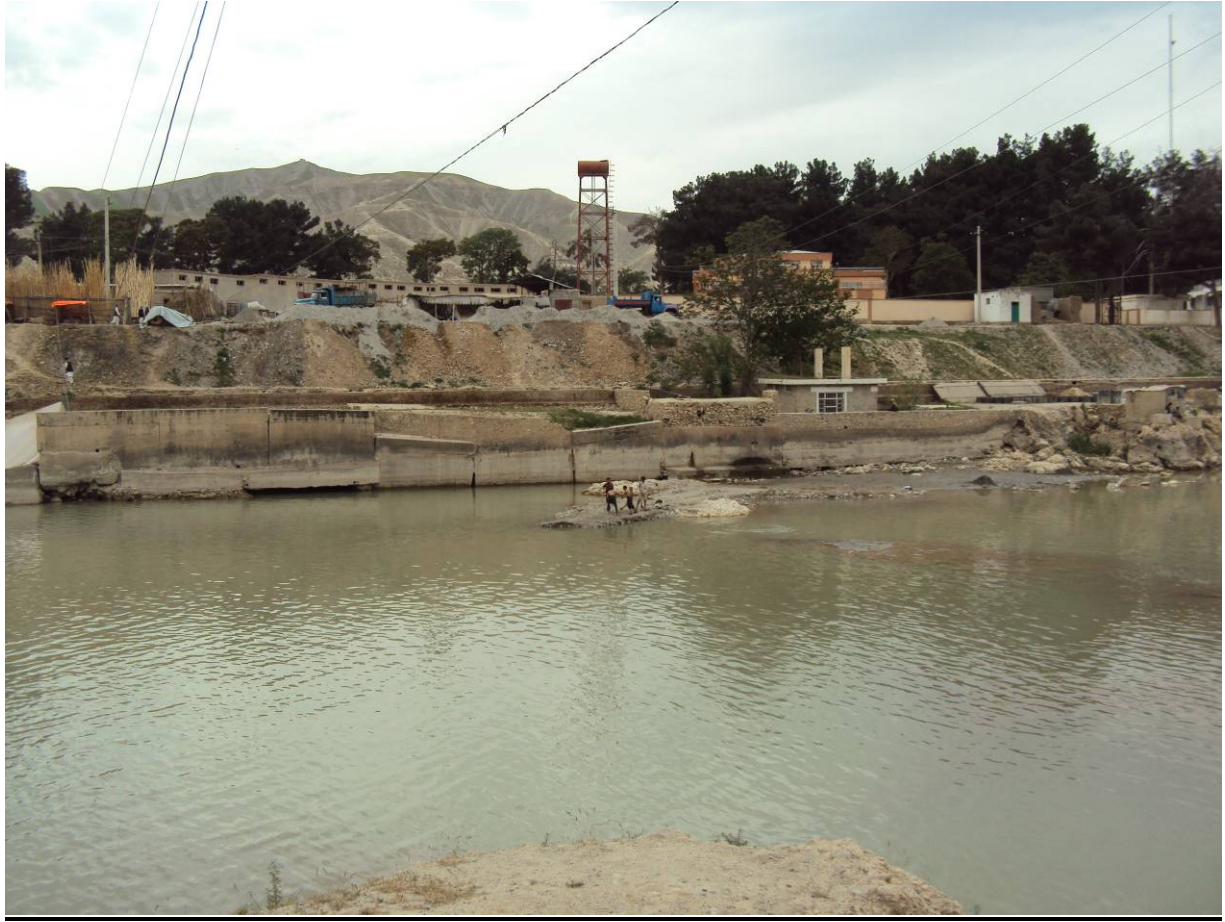
**View Indicates the Existing Damage to Concrete Wall Sections Further Along Left-bank Side of Baghlan River Downstream of Bridge Adjacent to Pul-e-Khumri I Hydroelectric Power Plant Facility.**

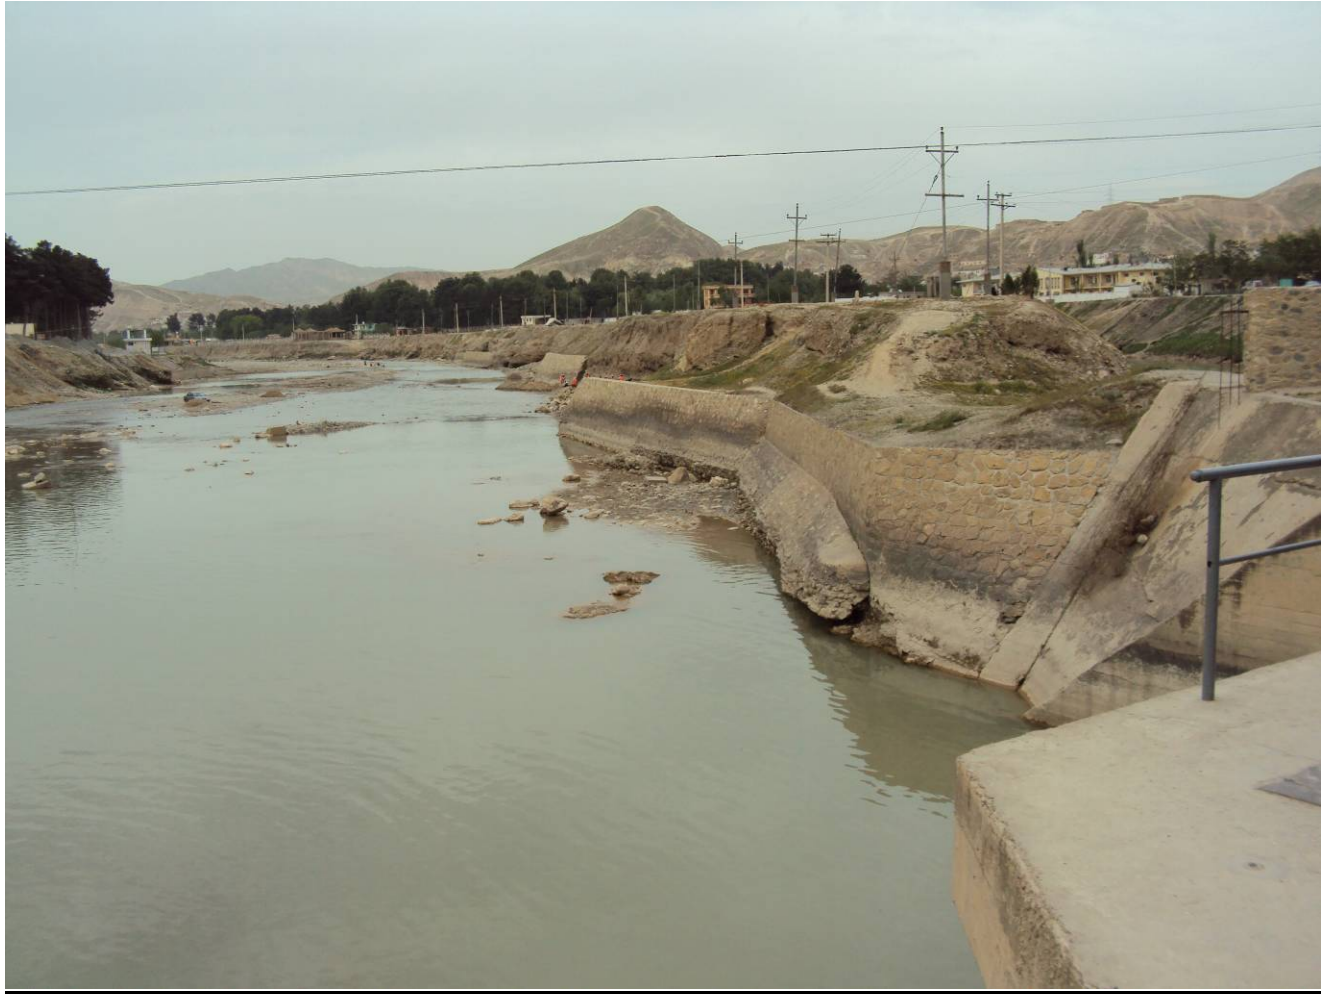
**View Indicates the Damage to Existing Low Concrete Wall Sections Along Right-bank Side of Baghlan River Downstream of Pul-e-Khumri I Hydroelectric Dam Facility.**

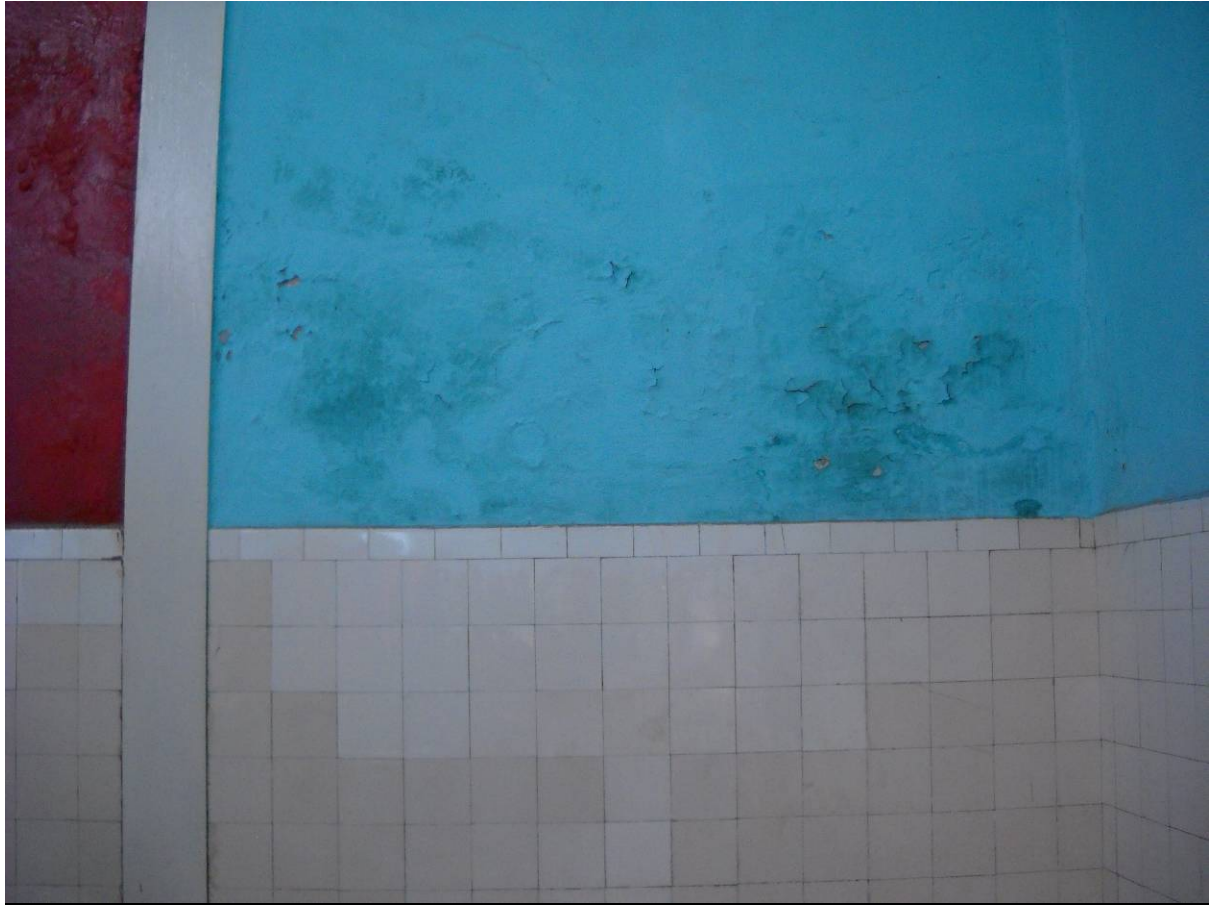
The power house roof leakage problem reported in the USACE April 2008 report reportedly has been temporarily fixed. Plant staff indicated that the leak areas had been patched using an asphalt roofing material. However, this roofing fix should be considered as being temporary only and complete replacement of the roof section may be necessary.

**View Indicates the Wall Damage from Leaky Roof in Pul-e-Khumri I Power House Building.**

**3) Repair Power House roof (mandatory).**

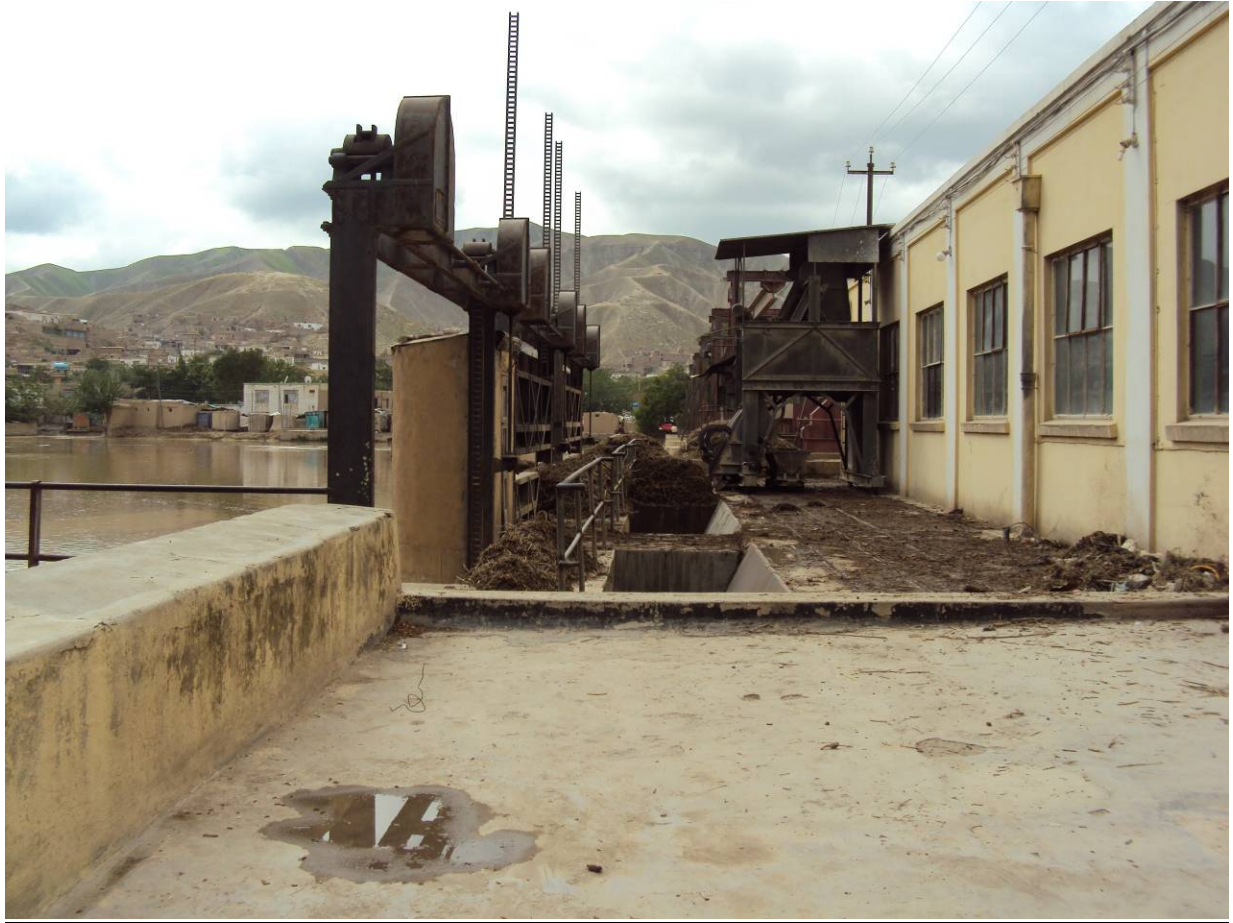
On 12 April 2010 during a second site visit, in the afternoon after a storm event had occurred during the previous night and when there was slight flooding on the Baghlan River, the river was observed to have a high sediment load above the dam. In addition, there was a significant amount of debris that had collected behind the dam and had already been removed to the top of the dam. It was observed that the trash racks and trash rake proved operational and functional and the equipment was capable of removing a significant amount of debris. However, to date, the proposed repair requirements for the trash racks and trash rake noted in the USACE April 2008 report have not been performed.

**View Showing the Debris that was Trapped and Collected as a Result of a Storm Runoff Event that Occurred the Night Before on the Baghlan River at the Pul-e-Khumri Hydroelectric Power Plant Facility. The Existing Trash Rack/Trash Rake Systems Worked Well.**

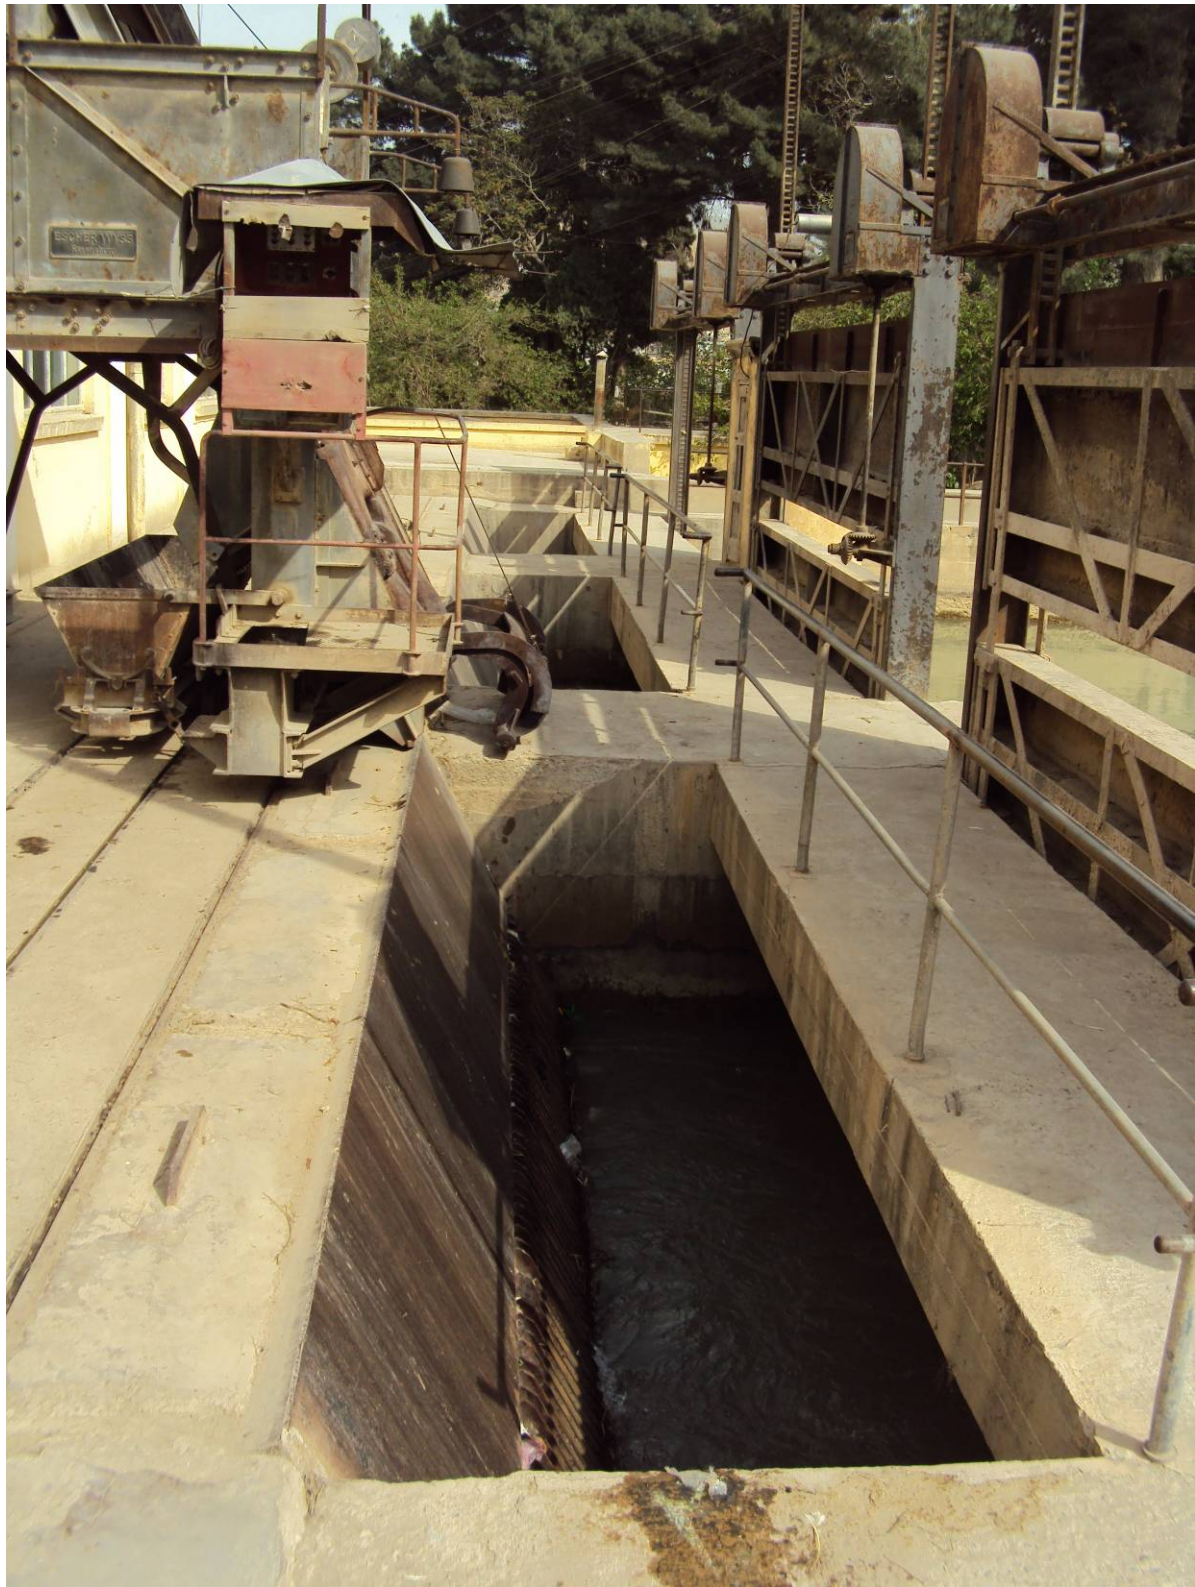
During Tetra Tech's two site visits to this facility, the trash racks and trash rake were noted as being operational and functional. The second site visit was made soon after heavy rainfall and minor flooding on the Baghlan River had occurred and it was observed that the equipment was capable of removing a significant amount of debris. To date however, the recabbling repair requirement noted in the USACE report has not been performed.

**Trash Rake Screen Assemblies at Pul-e-Khumri I Hydroelectric Power Plant Facility (before the Baghlan River storm runoff event occurred).**

**1) Procure 12-mm diameter wire rope for recabbling the existing trash rack using available plant labor forces (mandatory). During the USACE inspection, the trash rake was demonstrated and operated properly. However, the trash rake operator noted that a 12-mm cable that operates the rake teeth had failed in the past and had been replaced by a 10-mm cable because that's what they had available. The rest of the 12-mm cable on the trash rake was noted as showing wear as well.**

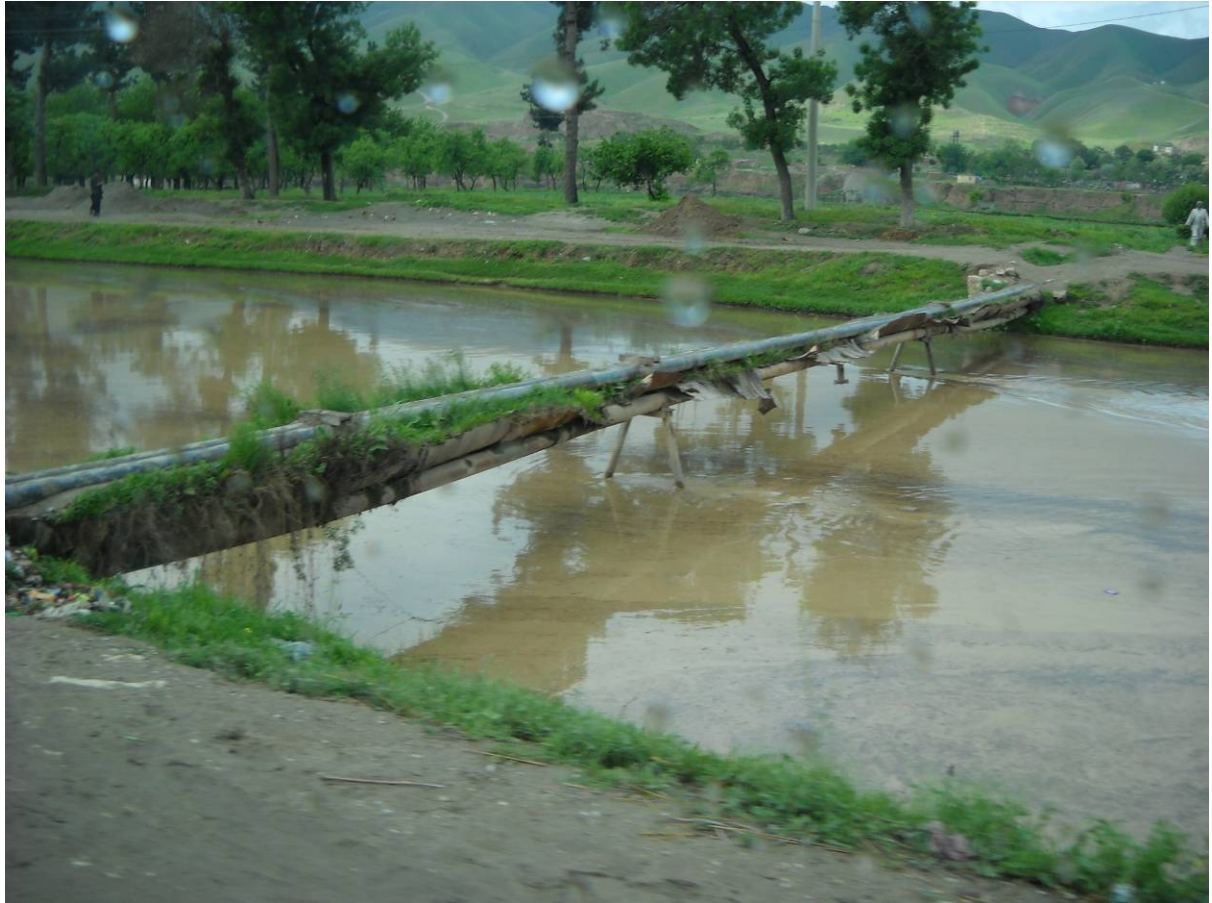
No work has been performed to date to remove the existing sediment in the power canal between the Pul-e-Khumri I and Pul-e-Khumri II hydro plant sites. While enroute to the Pul-e-Khumri I dam, Tetra Tech personnel observed that the water depth along the canal edges is extremely shallow, being close to about 1/2 meter. It was difficult to gage the water depth at the center of the canal, but it should be deeper in the main thread of flow. However, a significant dredging effort in this canal must be undertaken to remove the existing sediment along the approximately 6 km between the two plant sites if hydropower output is expected to be increased.

**Existing Sediment-laden Power Canal and Small Pipelines Crossing (reportedly two (2) meters of sediment depth needs to be dredged/removed along approximately six (6) kilometers of canal and disposed of at proposed off-site dump area located near Kar Kar, east of the City of Pul-e-Khumri (see text for discussion on recommended canal dredging activities)).**

Dredging the canal of the sediments (upwards of an estimated 300,000 cubic meters and more) is the only solution to achieve the former total carrying capacity of the canal needed for restoring the original power generating capacity of the existing dam facility. A selected dump site for the dredged sediments from the canal is reported to be located in the Kar Kar area (the grid for the general dump area is 42SVE7684) and is located approximately 20 to 25 km away from the City of Pul-e-Khumri.

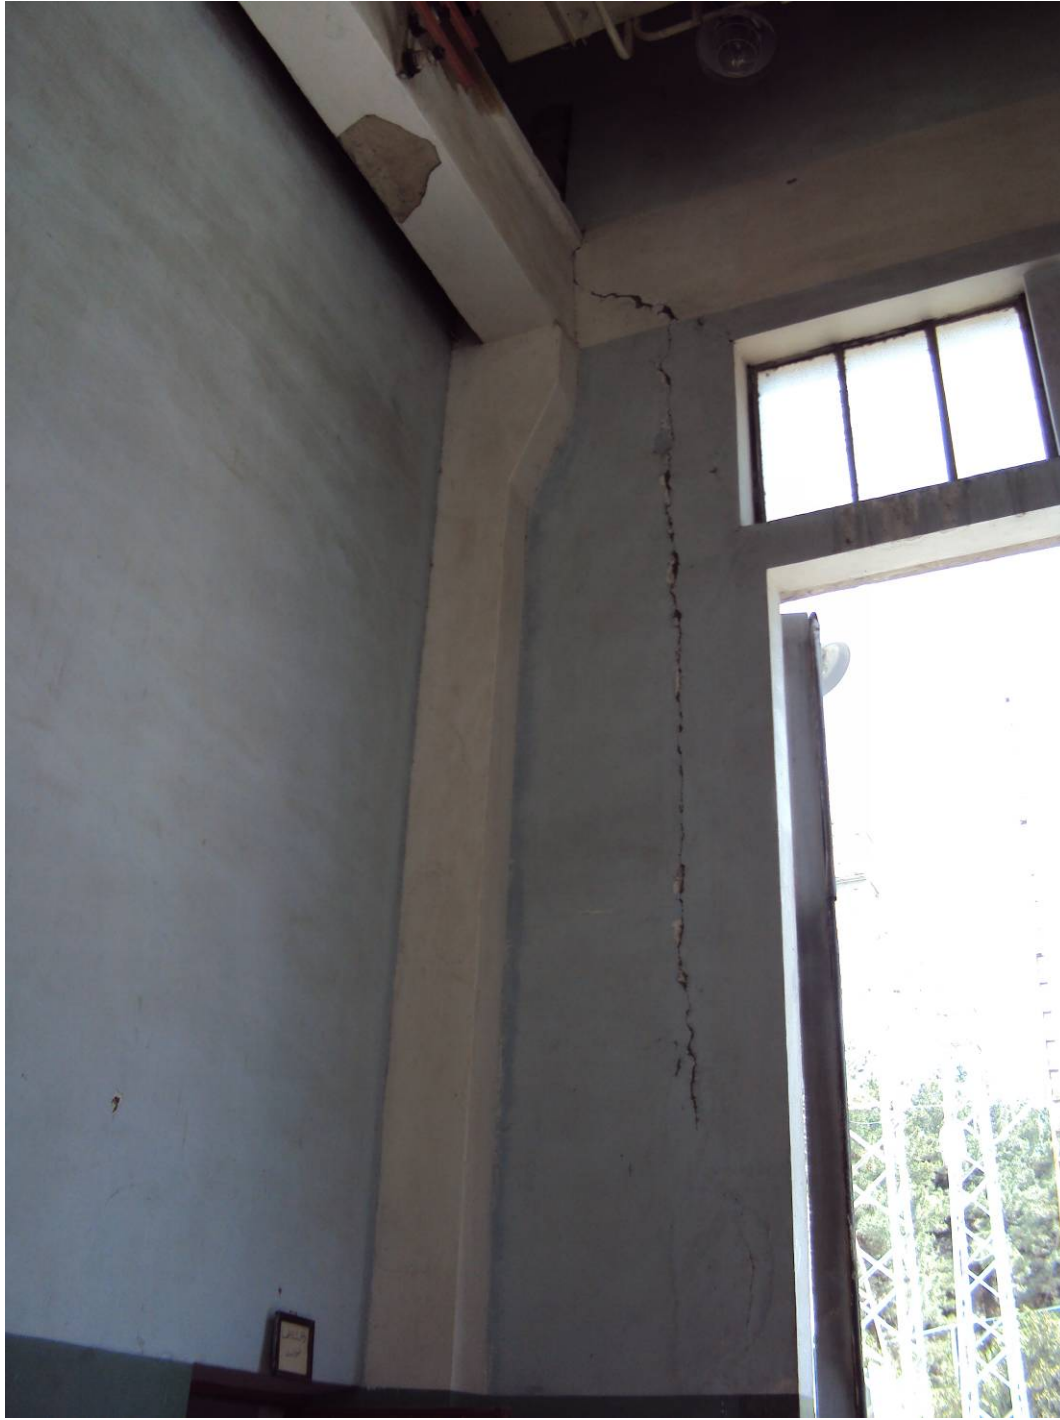
**Large Vertical Crack in Wall Running Generally Vertically Adjacent to and Just Inside and Between the Main Entrance and Column Corner of the Existing Power House Structure at the Pul-e-Khumri II Power House. Additional Cracks are Scattered at Various Locations on the Power House Walls. A Long-term Crack Repair Consideration will be Dependent on How Actively the Crack is Propagating and/or Enlarging, Including the Cracking Mechanism, and Verification of the Existing Structural Framing in the Area of the Column, Wall, and Header Features.**

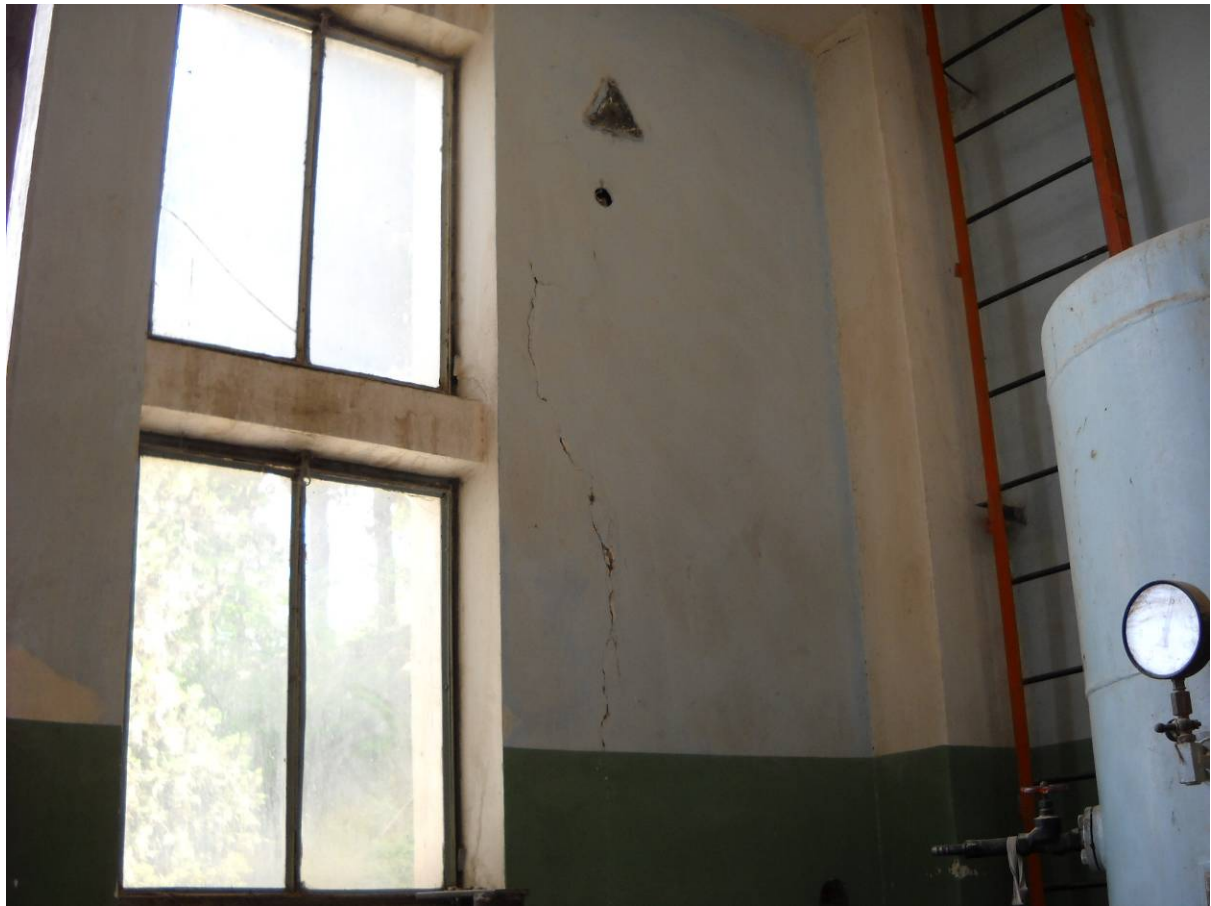
**A Second Large Vertical Crack in Opposite Wall Section Running Generally Vertically Adjacent to and Just Inside and Between the Windows and Column Corner of the Existing Power House Structure at the Pul-e-Khumri II Power House. A Long-term Crack Repair Consideration will be Dependent on how Actively the Crack is Propagating and/or Enlarging, Including the Cracking Mechanism, and Verification of the Existing Structural Framing in the Area of the Column, Wall, and Header Features. Additional Cracks are Scattered at Various Locations on the Power House Walls.**
